January 31, 2024

Indian River Club Association, Inc.  
1025 Rockledge Drive  
Rockledge, FL 32955

**Re: State Mandated Structural Milestone Inspection**

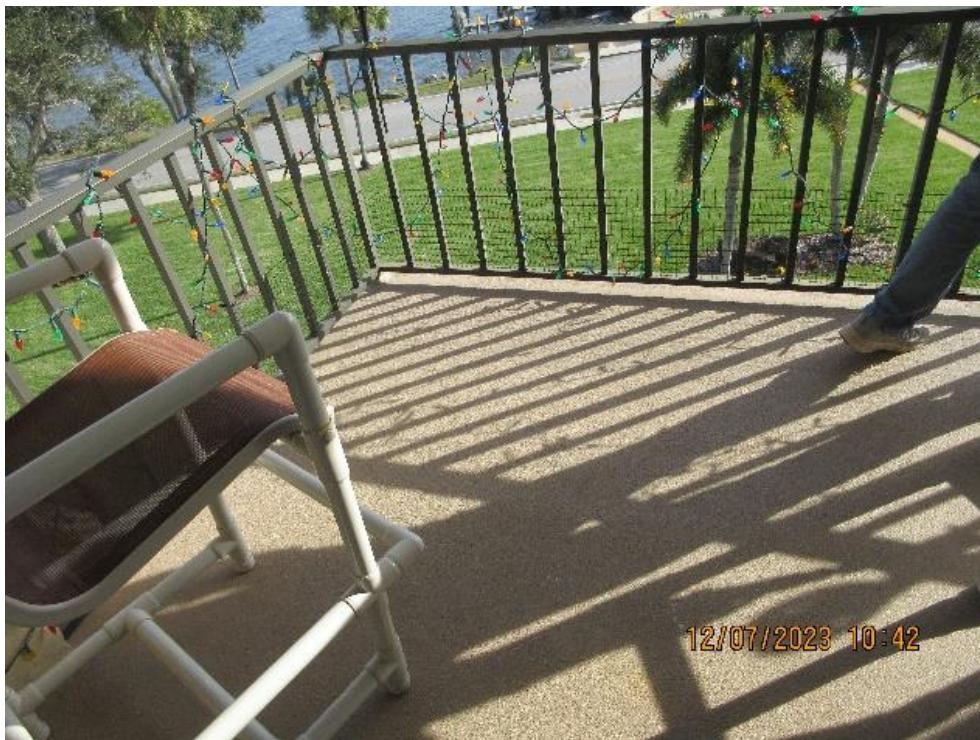
**View of typical balcony**

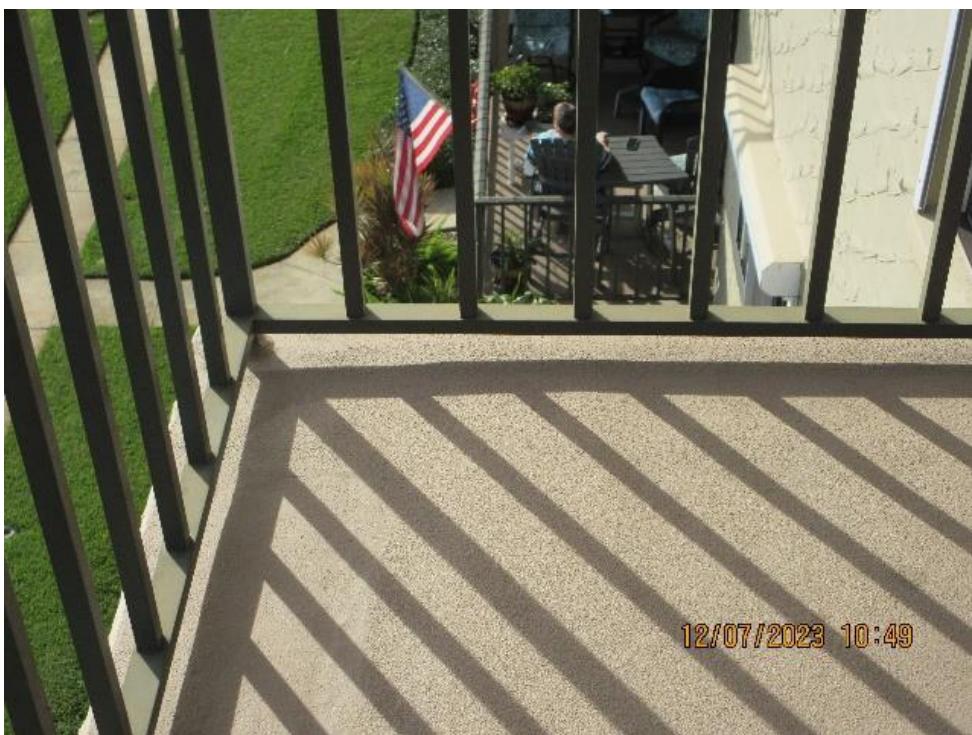
**View of typical balcony**

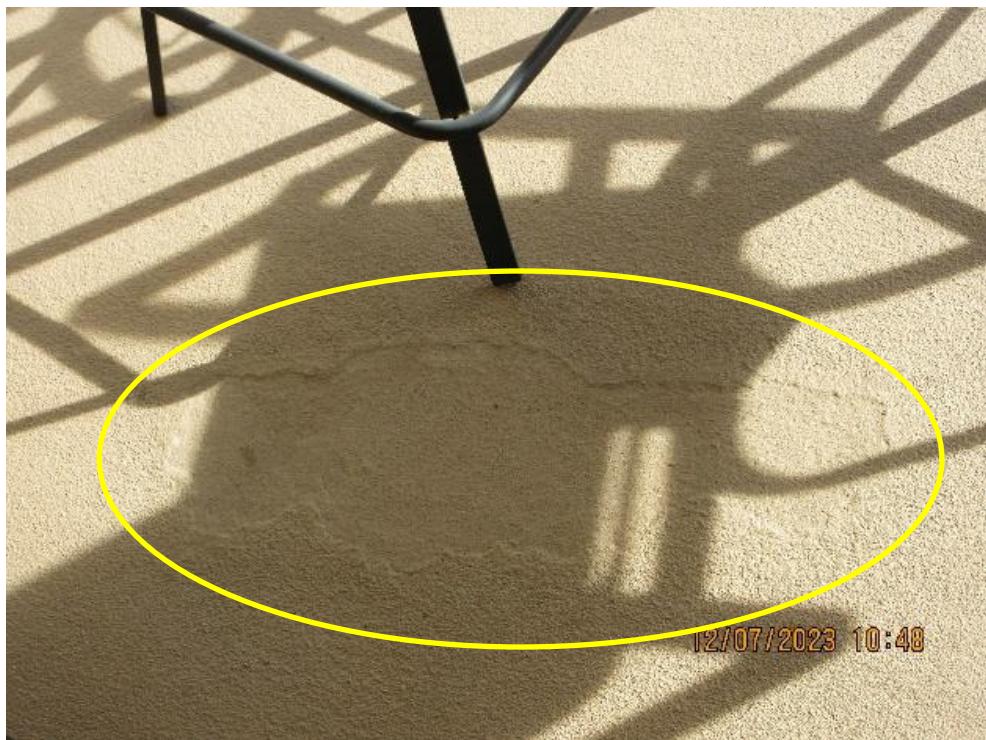
**Balconies** – As mentioned above, the balconies have been through several concrete restoration projects, most recently in 2017. The project included recommended protective measures which will greatly reduce future cyclic damage. We assume that since then, some reactive patching has occurred. The balconies currently have minimal visible signs of structural concrete damage. It is recommended to follow cyclic restoration cycles of 7 to 10 years, which will occur on any aged coastal building. These cycles should be planned for and coordinated with exterior building painting cycles (2025-2028). At that time, any needed concrete repairs would be completed, the floor coatings repaired as needed and fully top coated.

**View of missing texture to balcony coating**

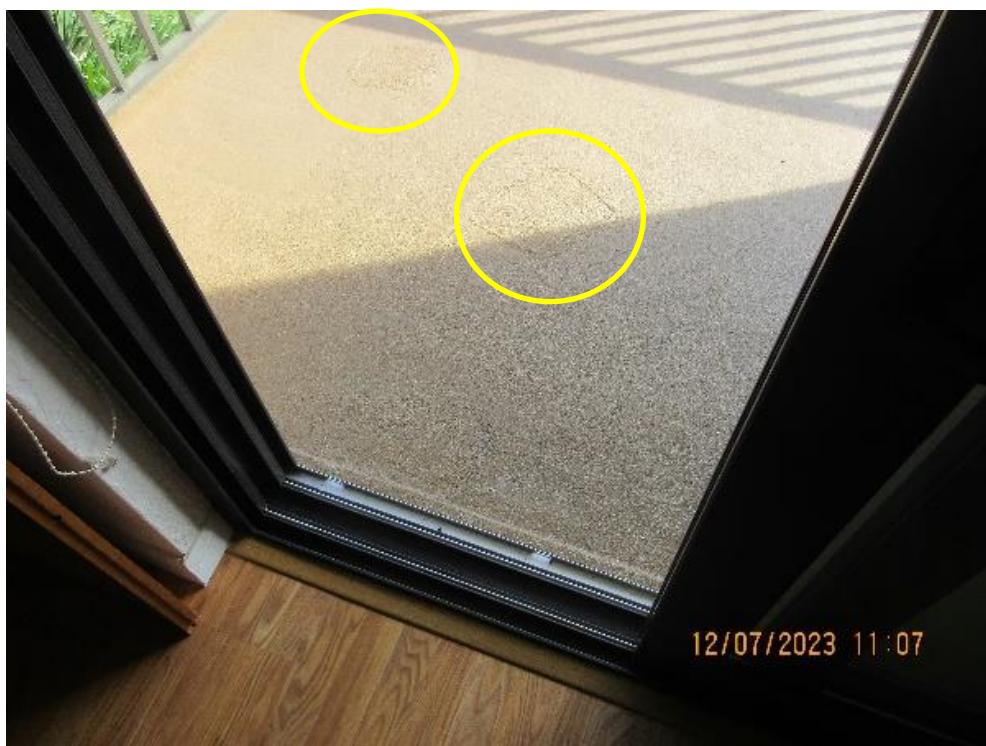
**View of concrete patches on balcony slab**

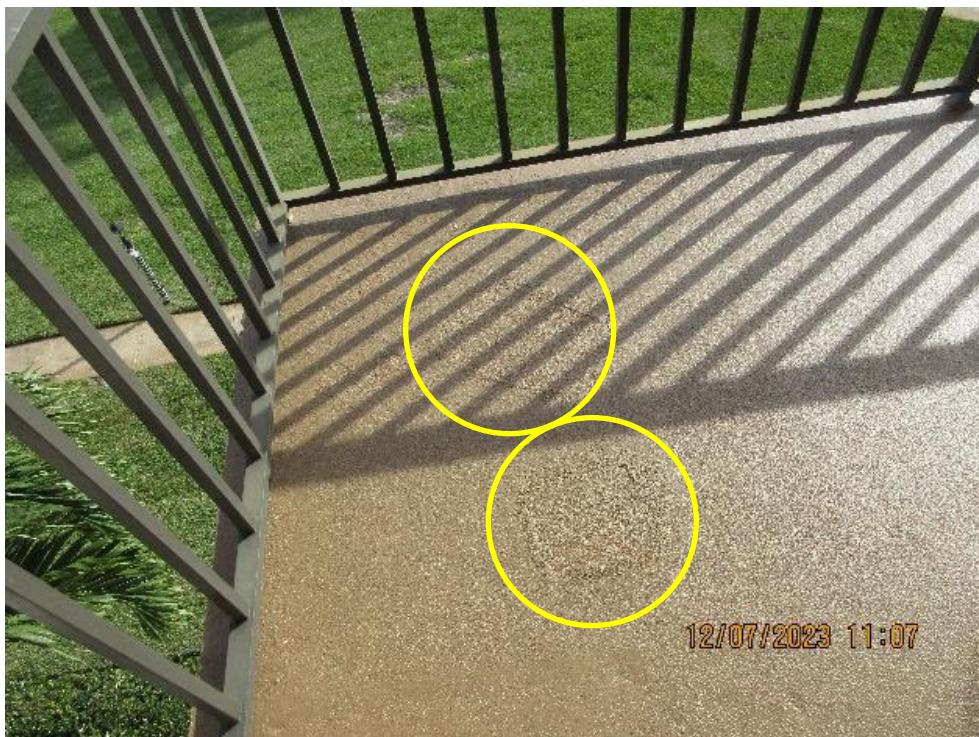
**View of concrete patches on balcony slab**

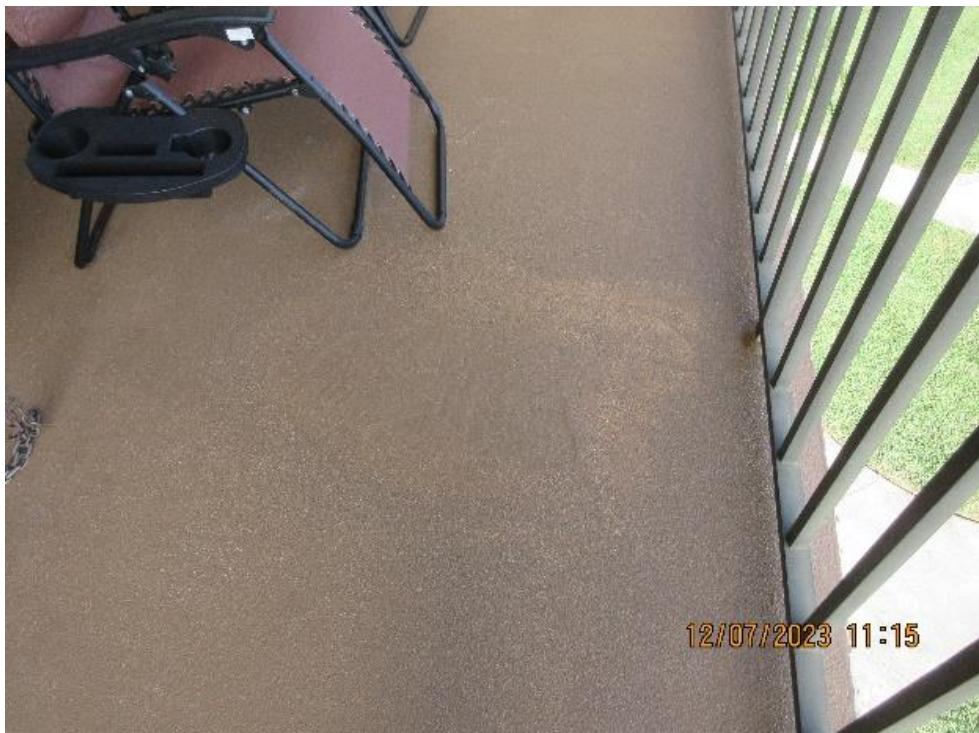
**View of missing texture to balcony coating**

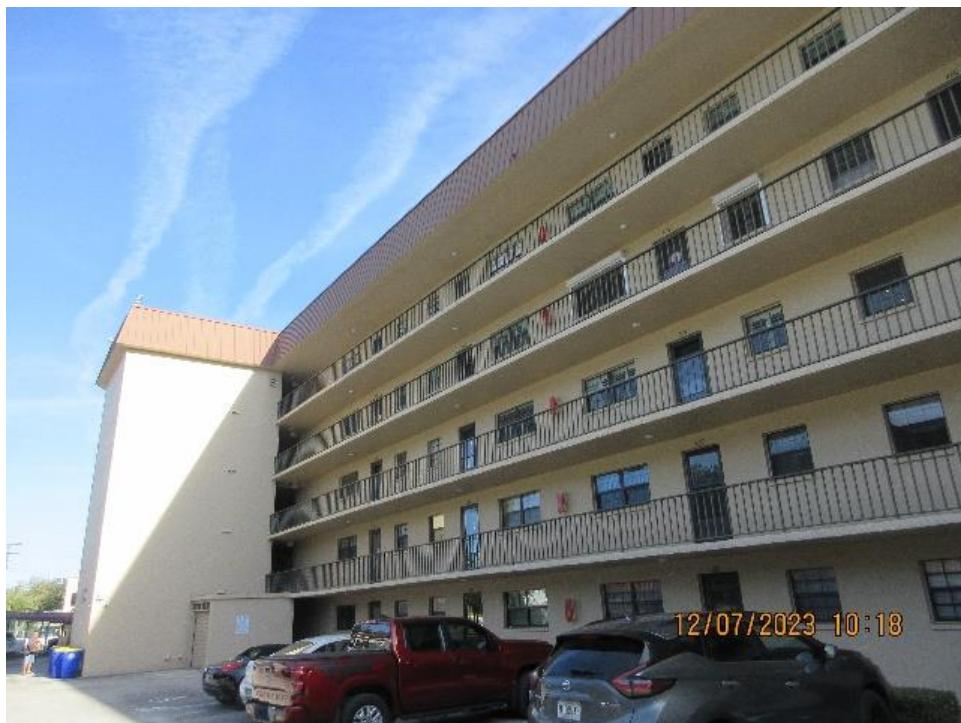
**Overview of typical walkway**

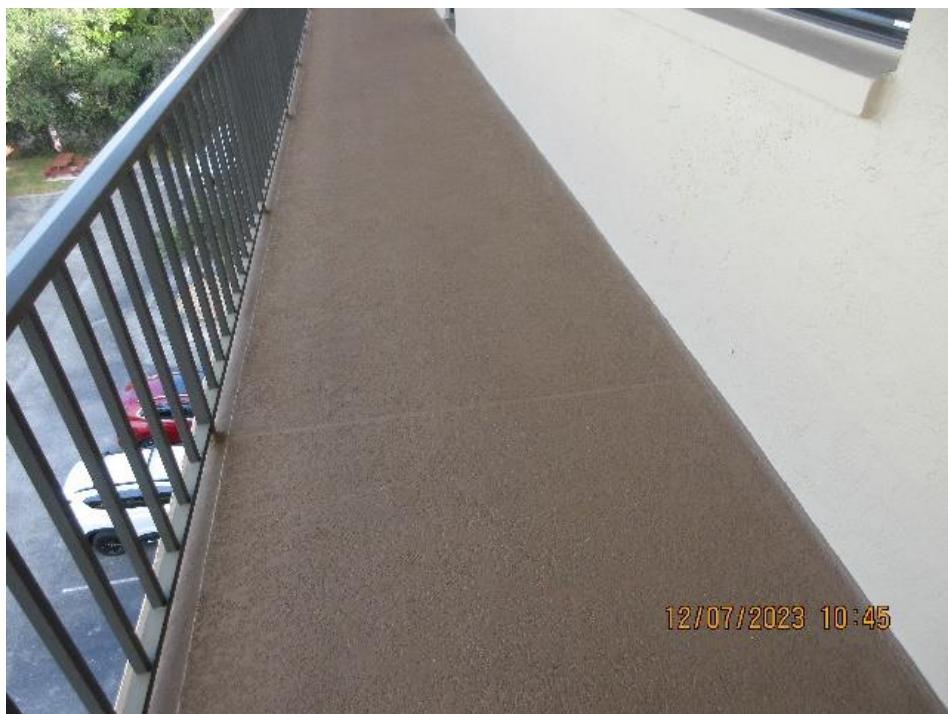
**View of typical walkway**

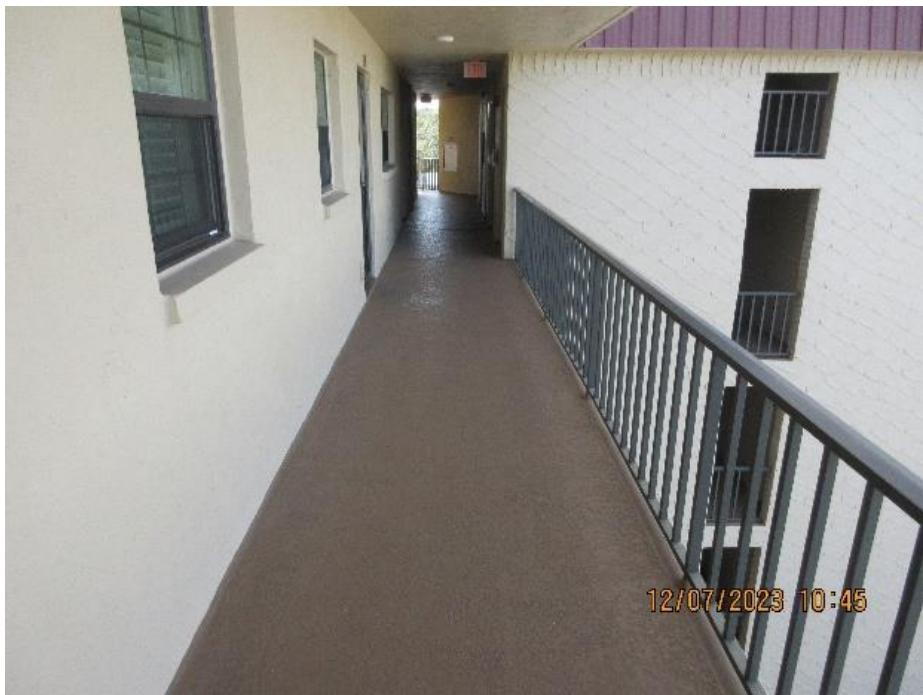
**View of typical walkway**

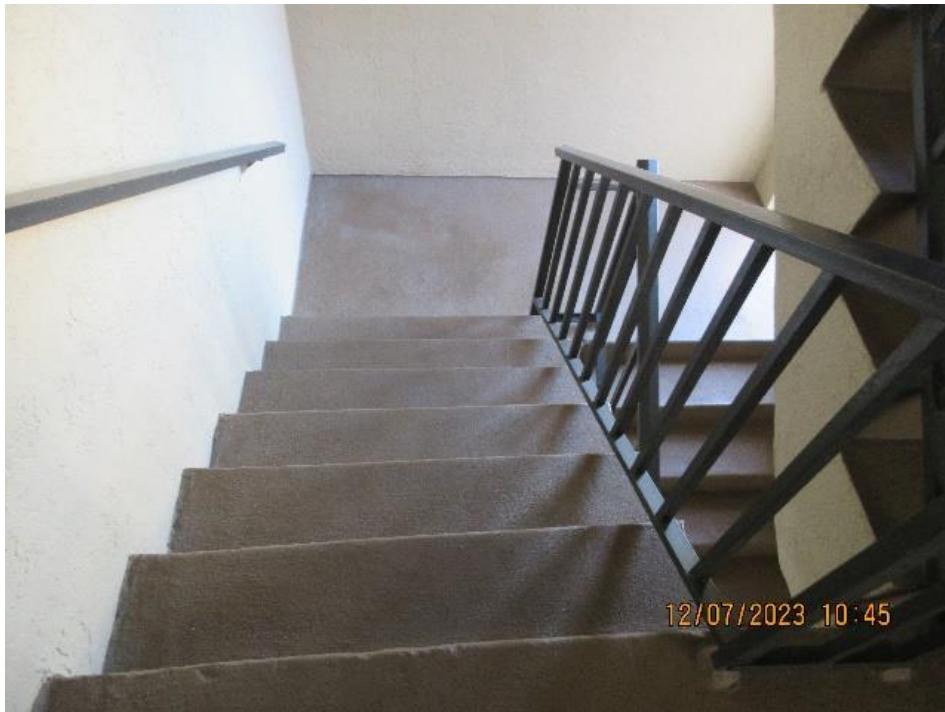
**View of typical stairway**

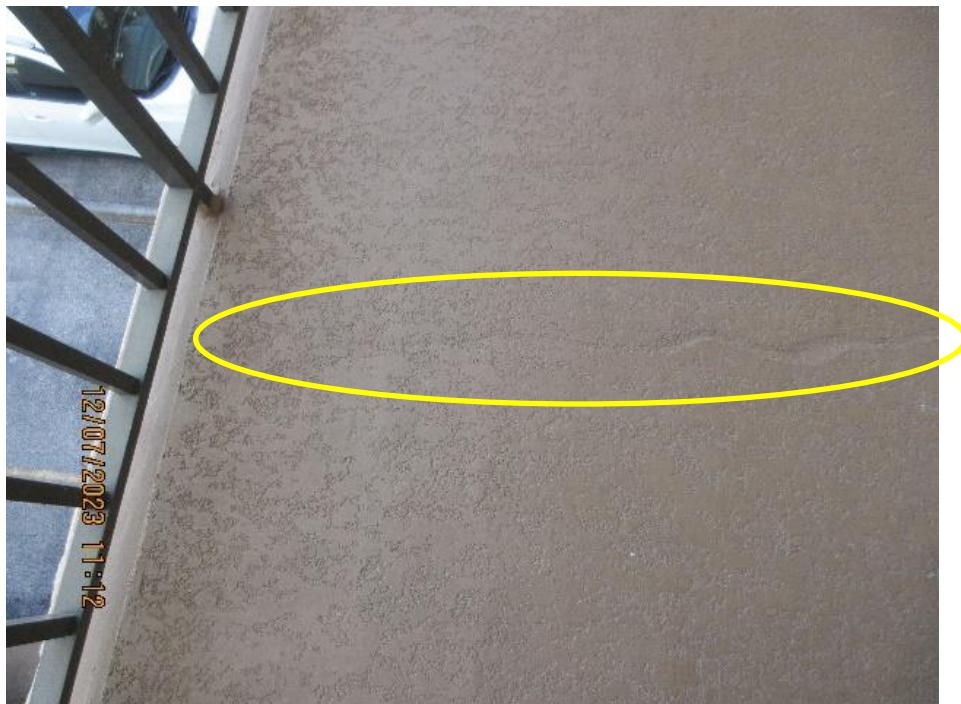
**Walkways** – The walkways had structural concrete repairs in 2017 as well. A new floor coating system was installed at that time. A visual and acoustic inspection was completed on all the walkways as part of this structural milestone inspection. Minimal concrete damage was visible. **It is recommended to follow cyclic restoration cycles of 7 to 10 years** for these repairs as well.

**View of crack along walkway coating**

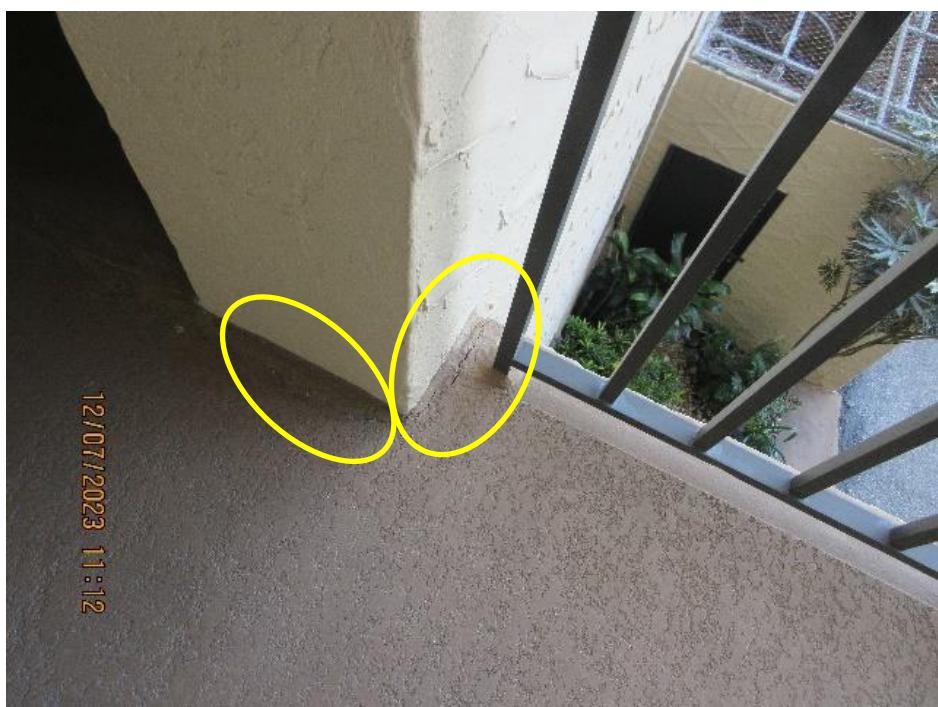
**View of crack at floor to wall joint**

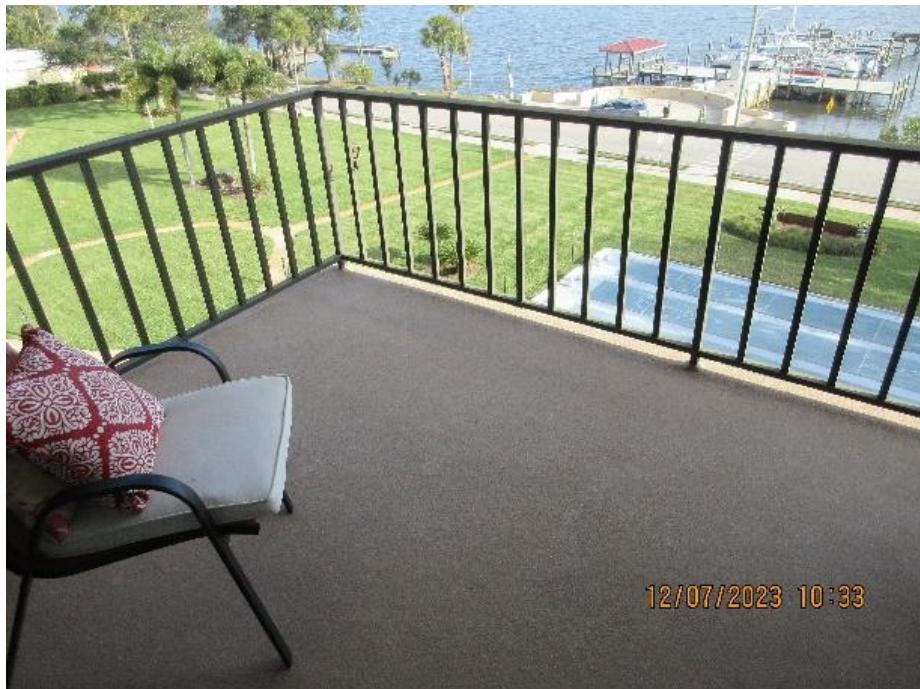
**Railings** – The balcony and walkway railings are “cored in place” railing systems. They are original to the building and are known to accelerate and exacerbate concrete spalling, particularly at the slab edges. Cored railings feed salt-water into the slab on a nearly continuous basis. This causes corrosion of the reinforcing steel at the slab edge and requires the common repair known as a balcony edge slab repair. In most cases, these slab edge repairs can be directly attributed to the presence, past or current, of cored railings. The railing picket spacing does not meet current building codes, but can remain in place if not removed. The railings are also the older 36 inch height. Current codes require a 42 inch height. Railings should be replaced with new 42 inch, surface mounted railings during the next repair cycle in 2025 – 2028.

**View of cored in place balcony railing**

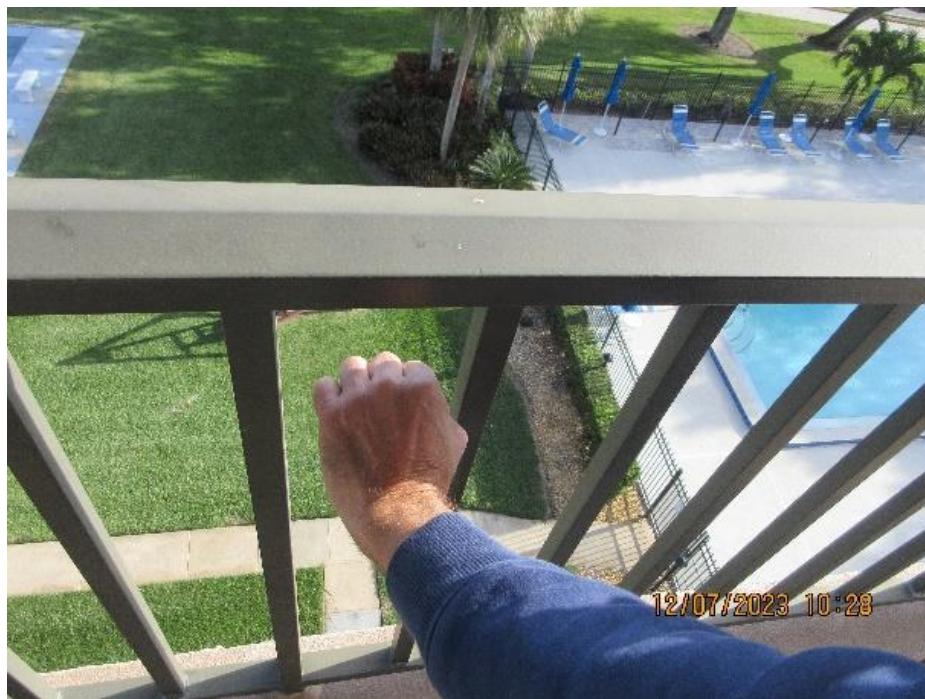
**View of balcony railing picket spacing**

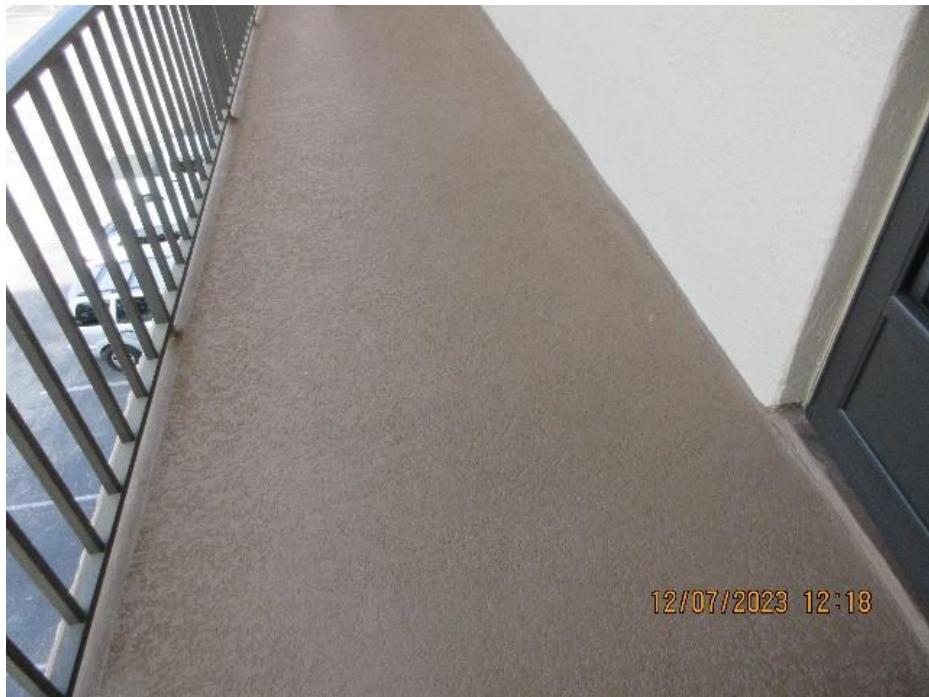
**View of cored railings along walkway**

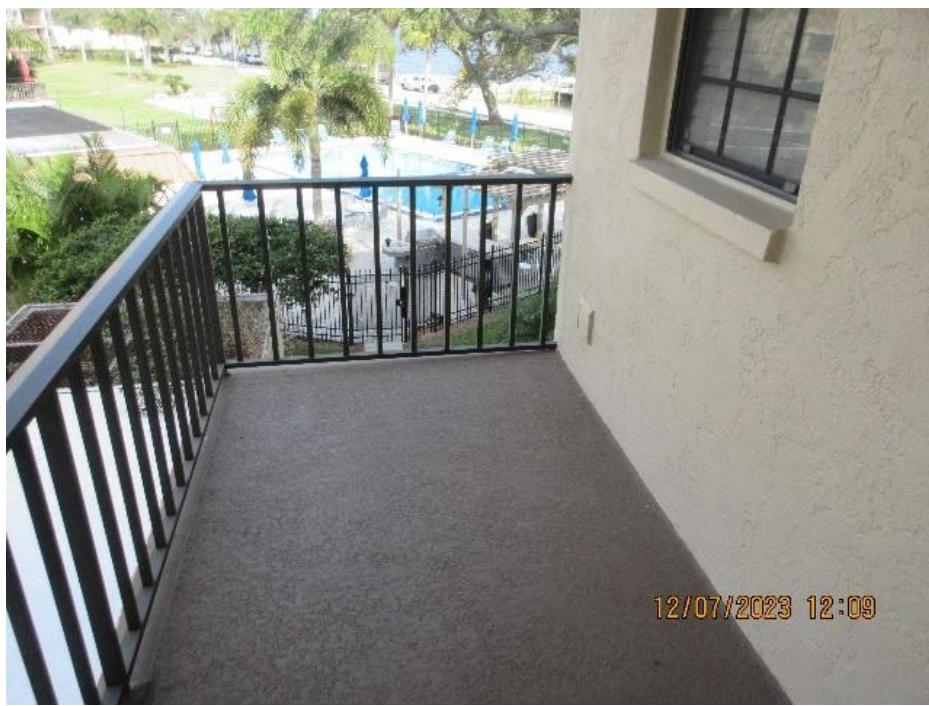
**View of cored railings along walkway**

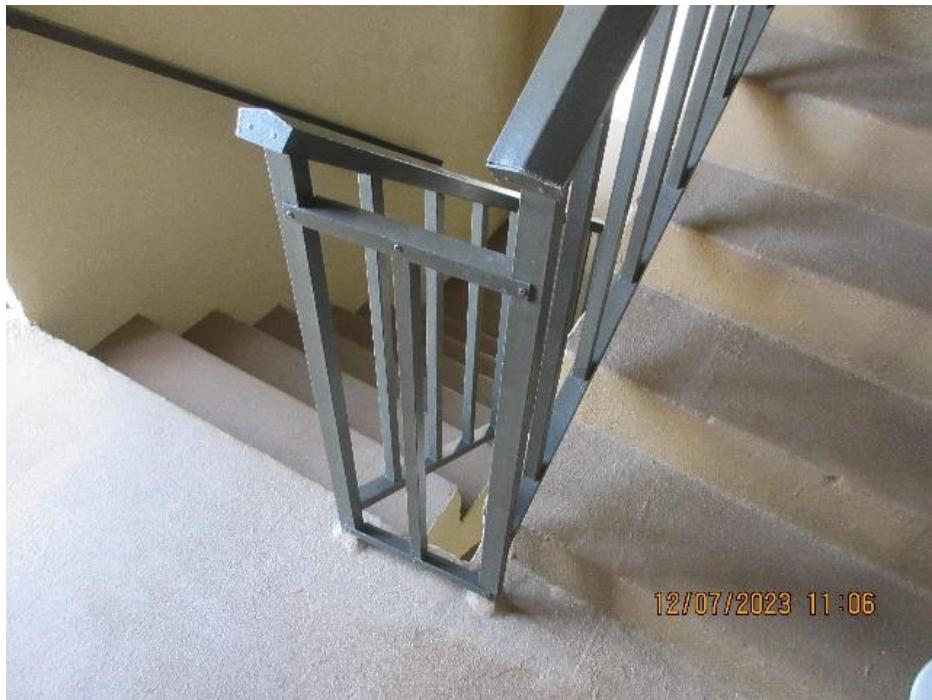
**View of cored railings along stairwell**

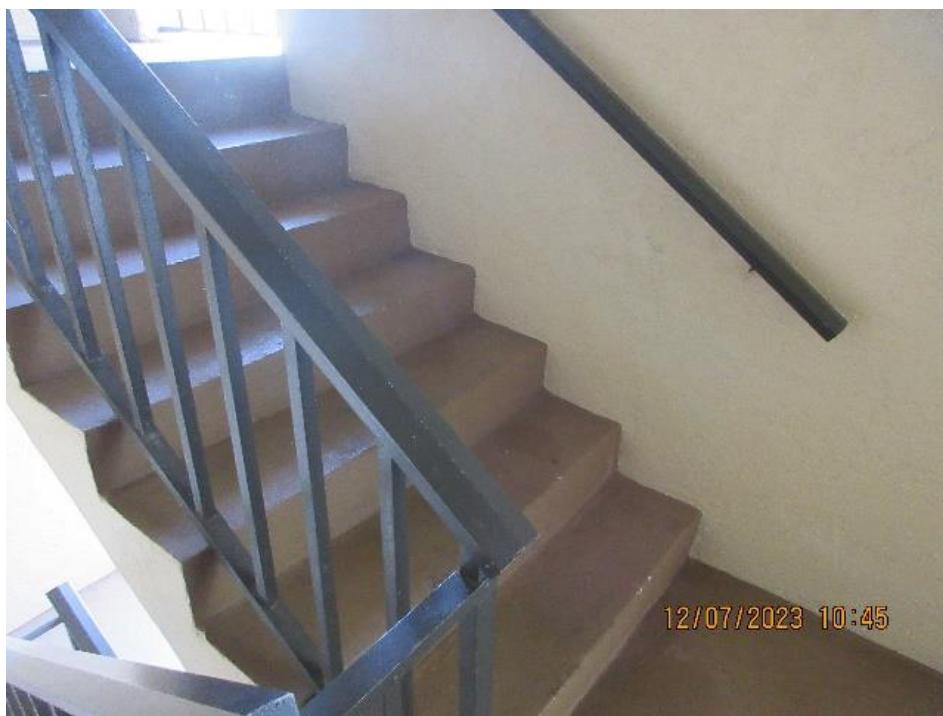
**View of cored railings along stairwell**

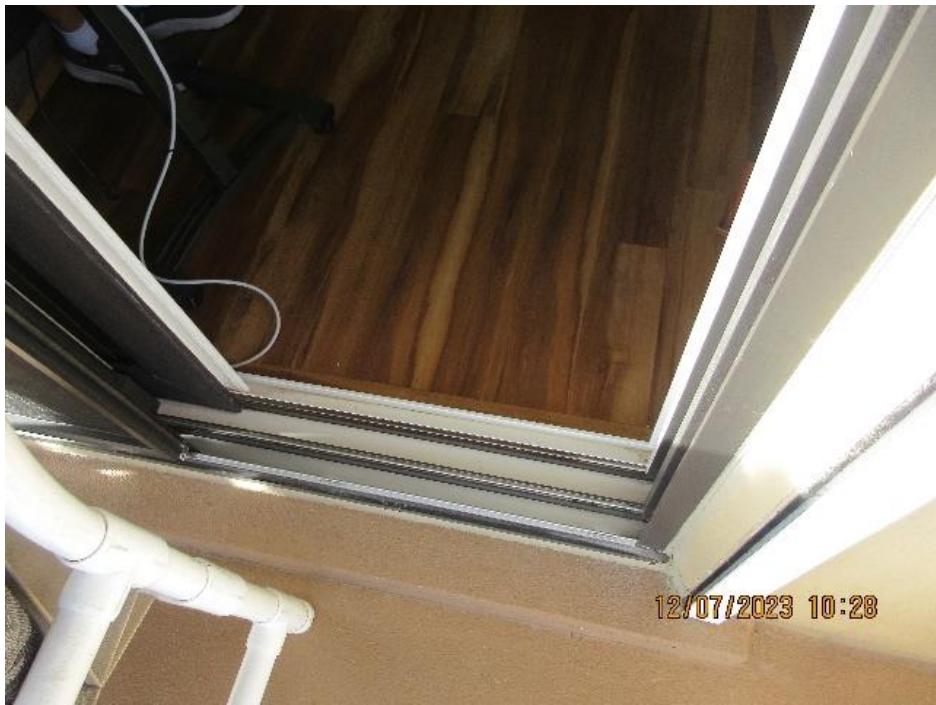
**View of newer sliding glass door**

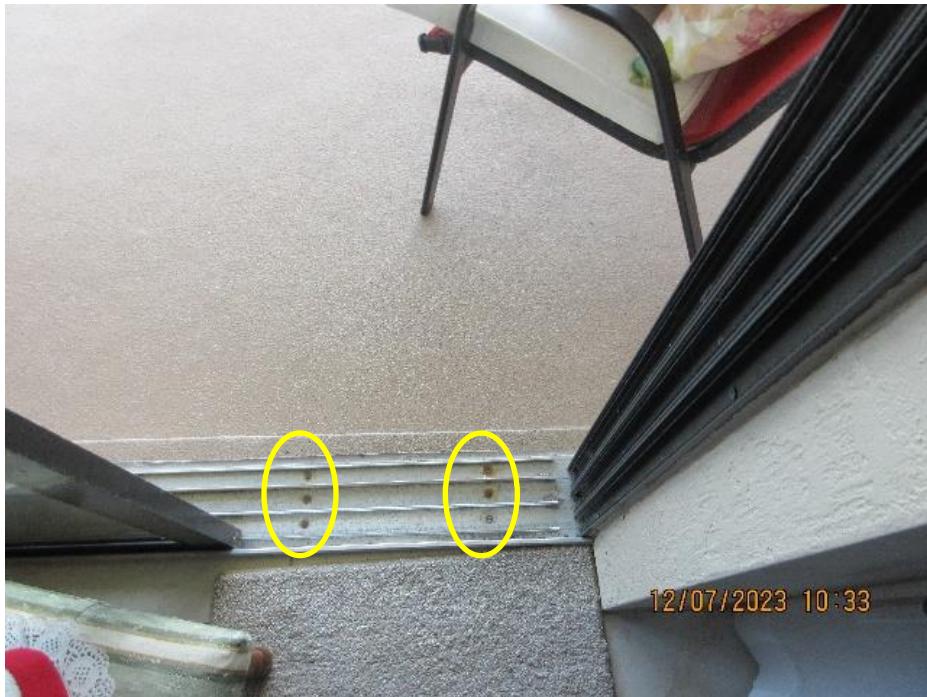
**View of sliding glass door track with corroded fasteners**

**Sliding Glass Doors** – A majority of the sliding glass doors have been replaced throughout the years. Any aged sliding glass doors remaining, should be replaced as part of the next restoration cycle. Any corroded fasteners should also be replaced.

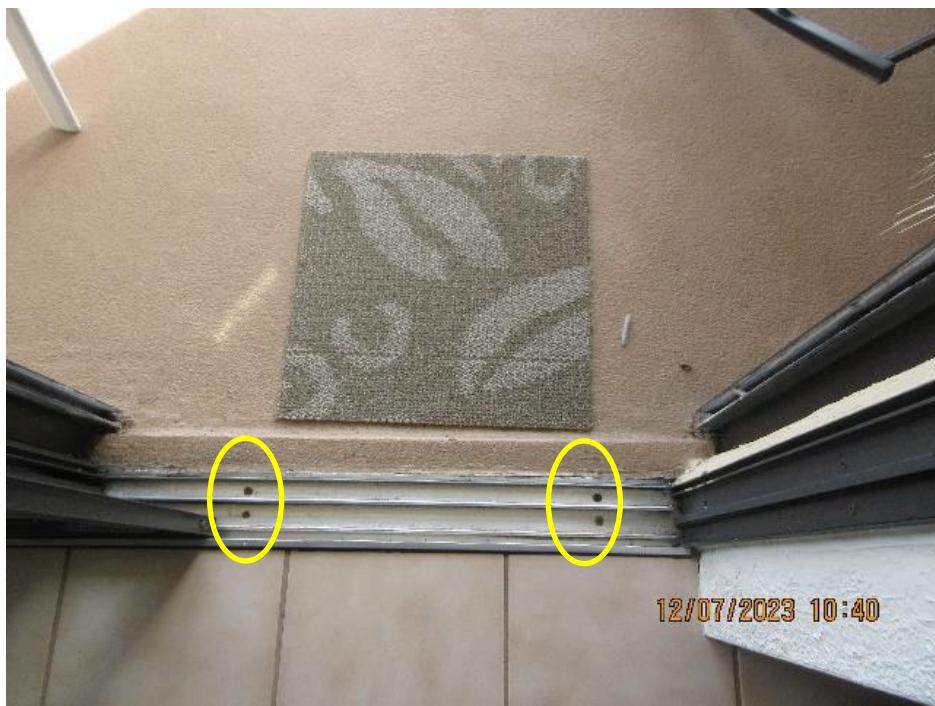
**View of corroded fasteners at sliding glass door**

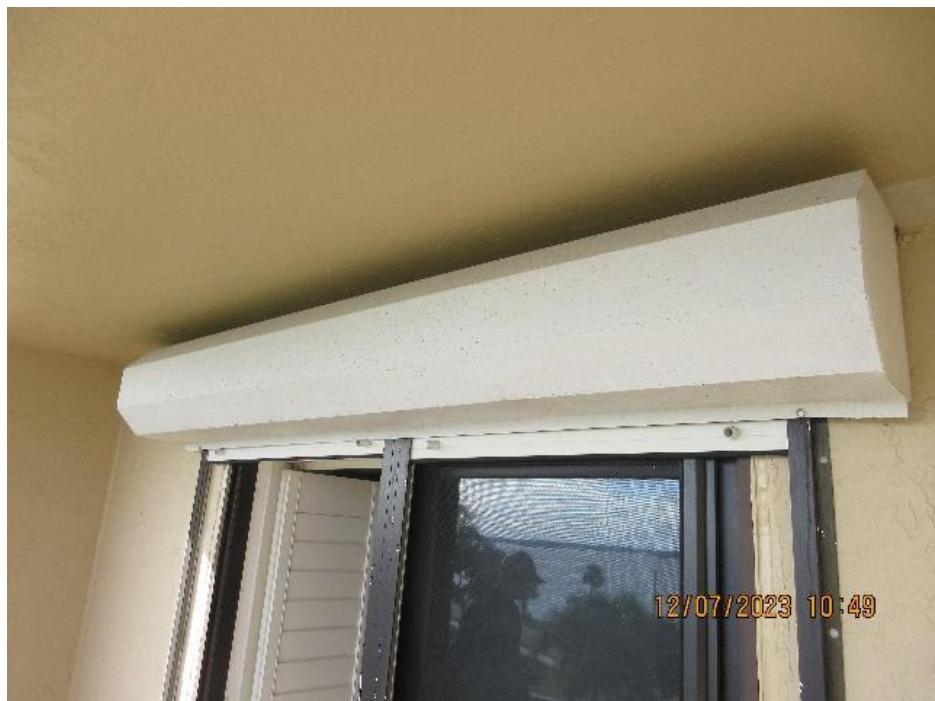
**View of shutter installed at sliding glass door**

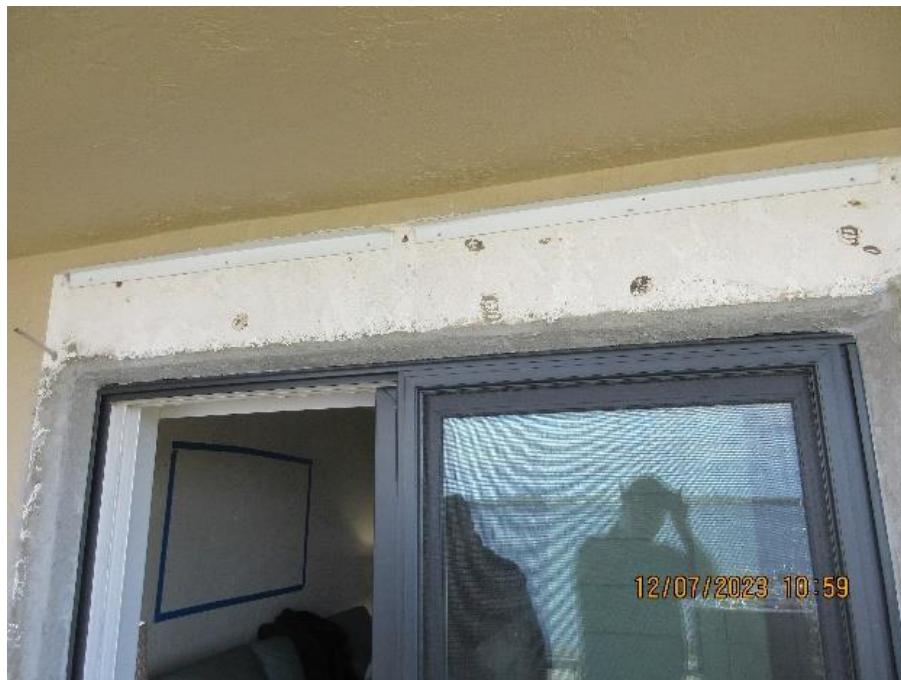
**View of uncoated area under former shutter**

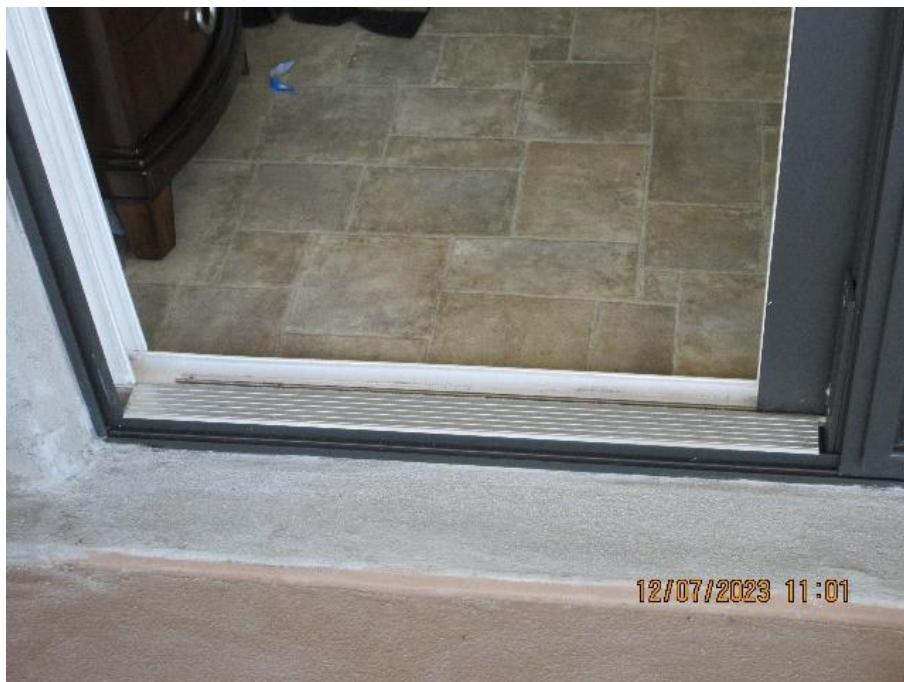
**View of stucco work at sliding glass door location**

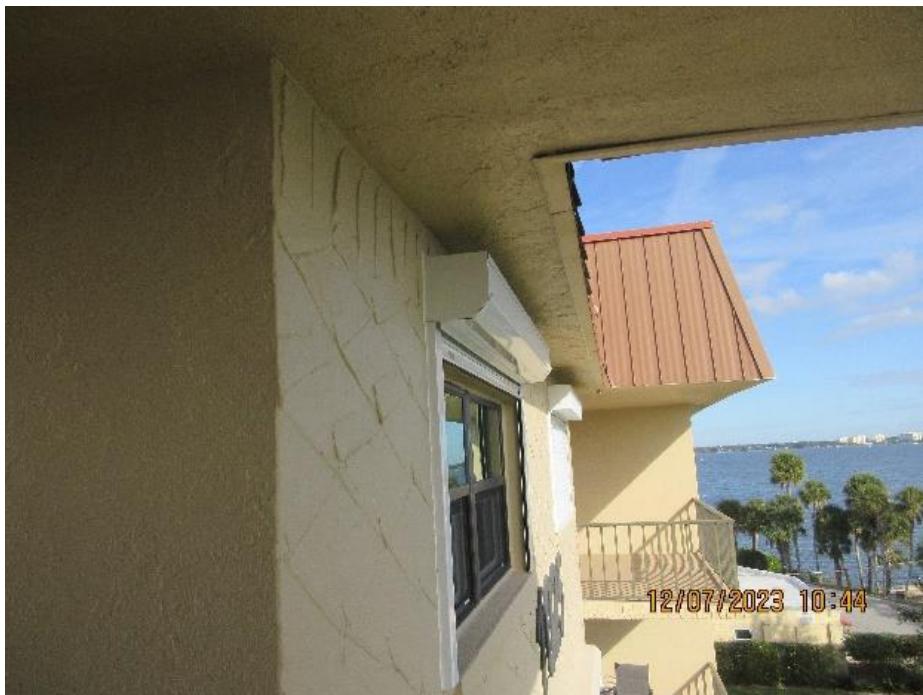
**View of coatings on east elevation**

**Exterior Wall Painting** – Painting was last completed in 2018. Painting should be completed as part of the next restoration cycle. Any concrete repairs needed should be completed at this time. **Painting cycles are recommended at seven to 10 years.**

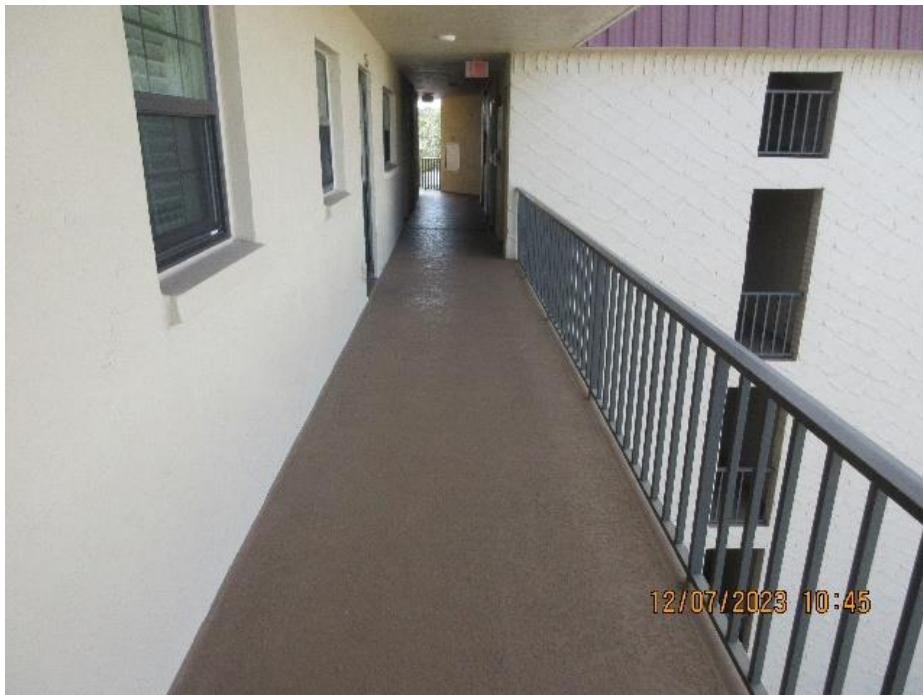
**View of coatings on west elevation**

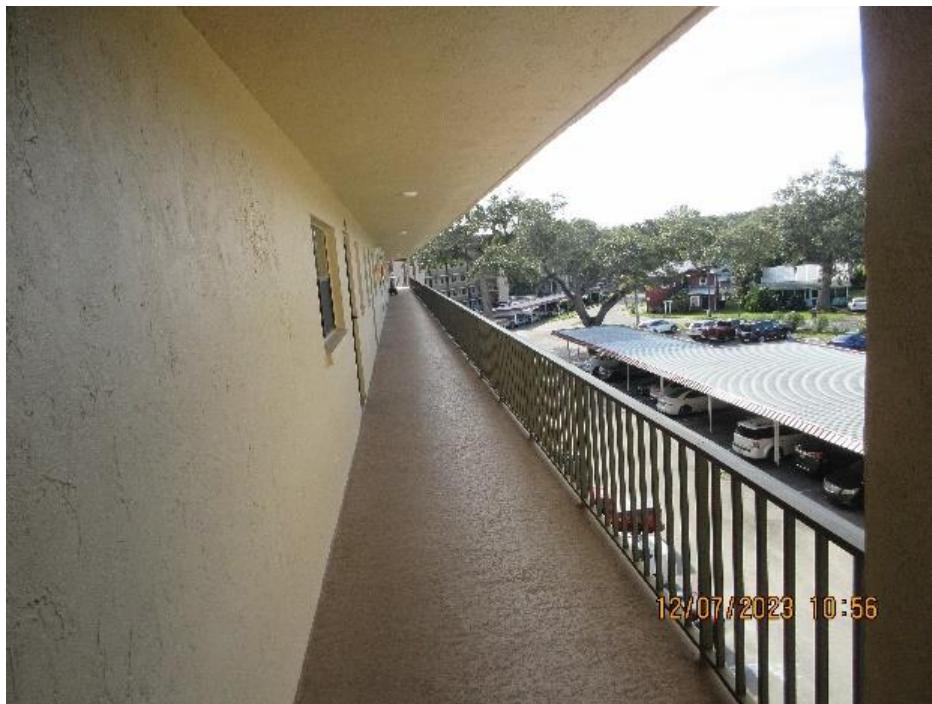
**View of coatings along walkway**

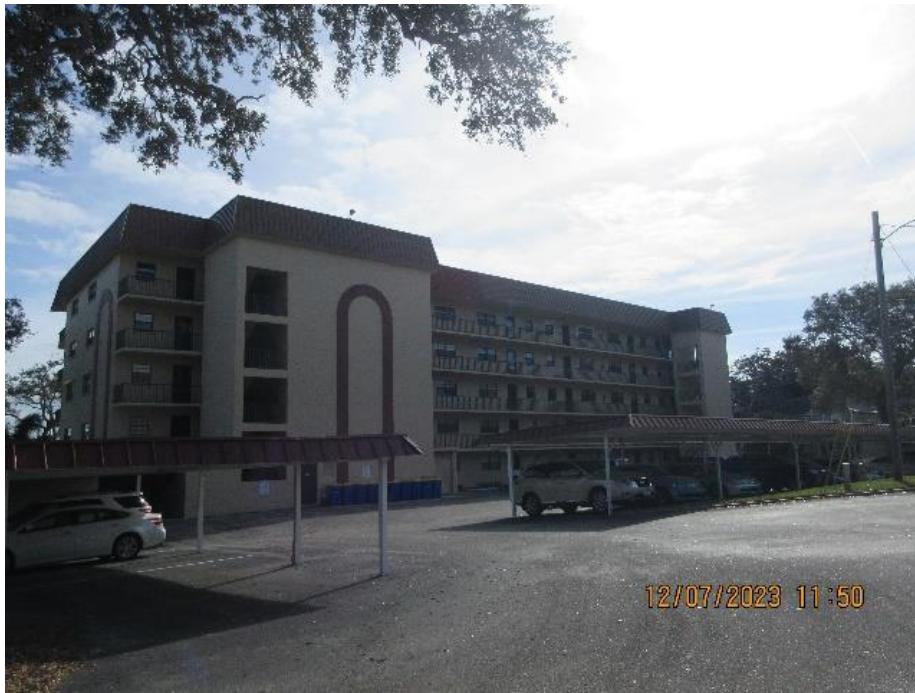
**Overview of B Building coatings**
